BUILDING 1010

CONDITION SURVEY DATA SHEET

CONDITION SURVEY

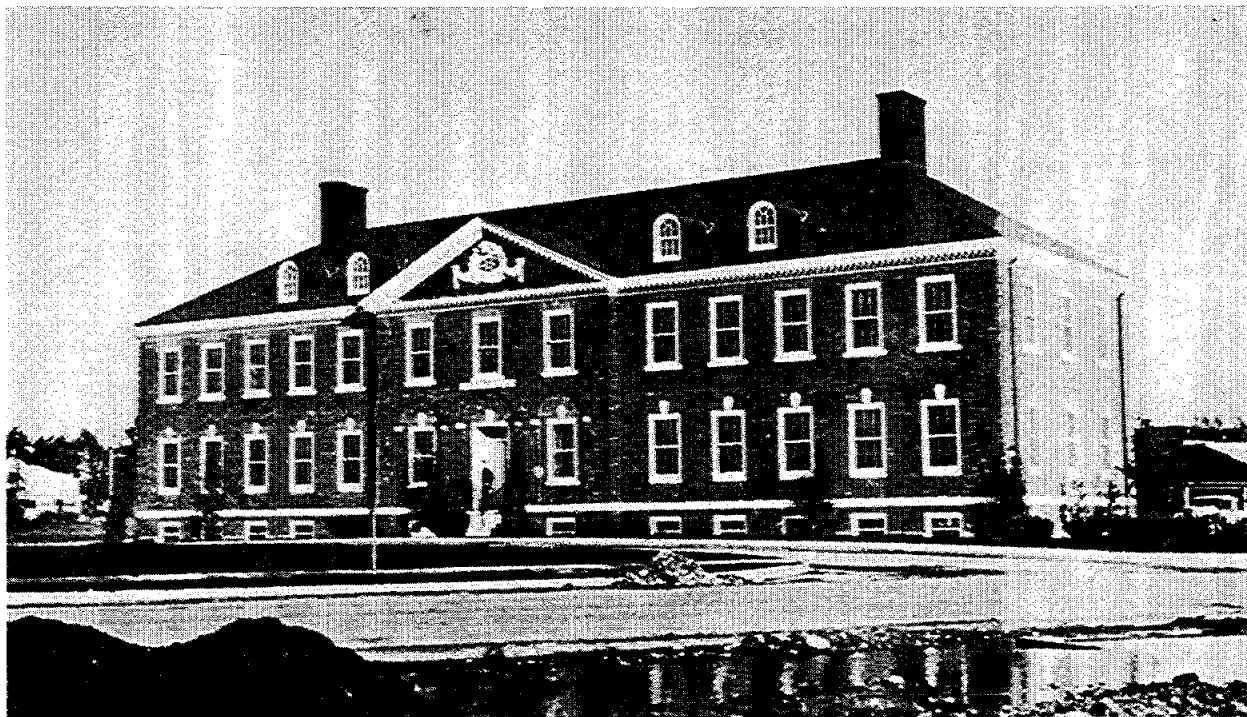
Building 1010 (formerly 1) was completed early in 1935 as the Headquarters and Administration Building. It is an excellent example of Georgian Revival architecture with its central pediment adorned with an oval window embellished by carved stone. It is T-shape in plan with exterior brick veneer walls, and a hipped roof with flat clay tiles.

The structural system consists of reinforced concrete frame and foundation, and structural concrete floor slabs. The roof over the east wing is supported by steel trusses, the remaining being supported by a standard post and beam system. This may be the only building on base with a built-in cornice gutter.

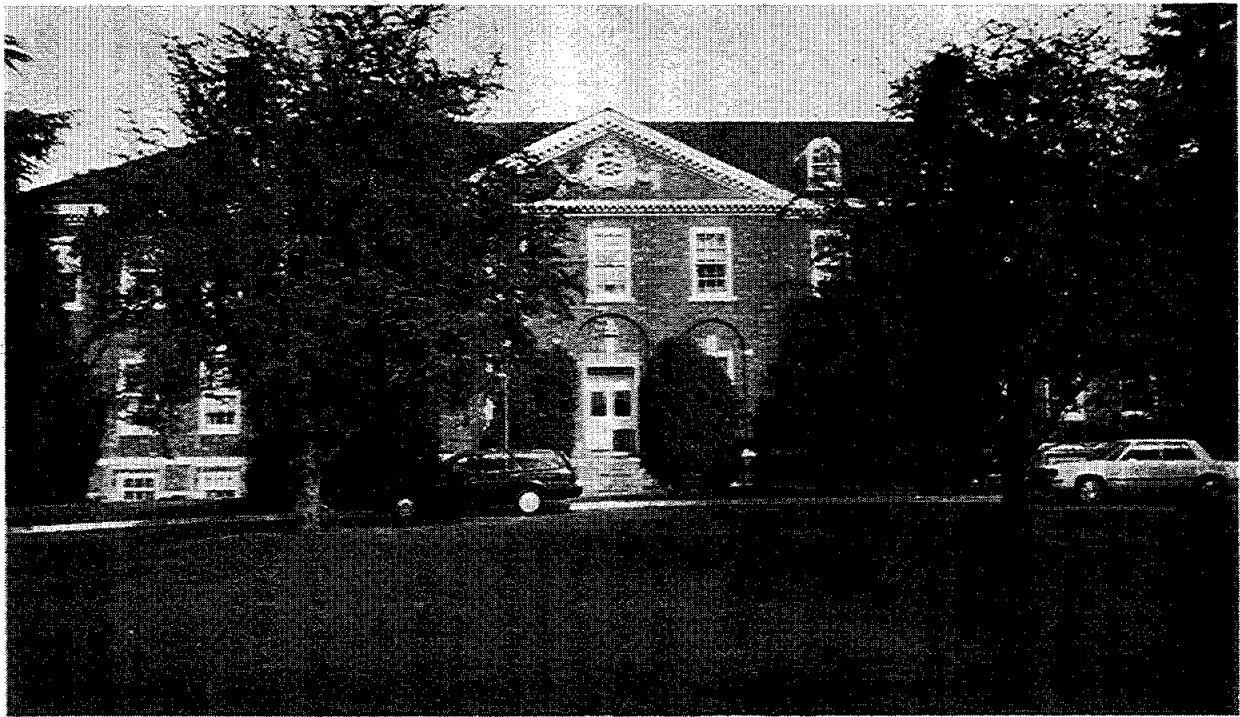
1987 PHOTO

Like all buildings in this study, the exterior remains basically unaltered. Steel hanger "eyes" set in the brick above the east end loading dock suggest that there may have at one time been a canopy here. Two windows have been bricked in on the second floor, east end.
